Navajo Abandoned Uranium Mine

Site Screen Report

Mine Name: Starlight
Mine ID: 701

Navajo AUM North Central Region

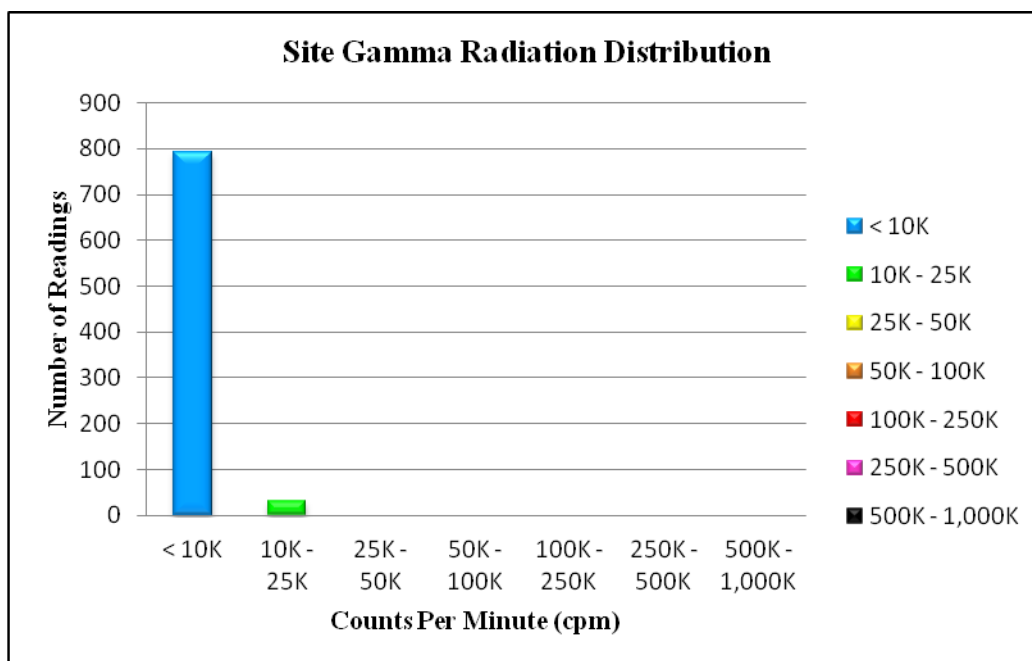
Distribution Chart and Statistics:

A total of 823 gamma radiation measurements were collected from the mine site, ranging from 5,669 cpm to 12,672 cpm. The measurements are represented in Figures 1 and 2.

Site Gamma Radiation Statistics	
Number of Readings	823
Minimum (cpm)	5,669
Maximum (cpm)	12,672
Mean (cpm)	7,842
Median (cpm)	7,723
Standard Deviation	966

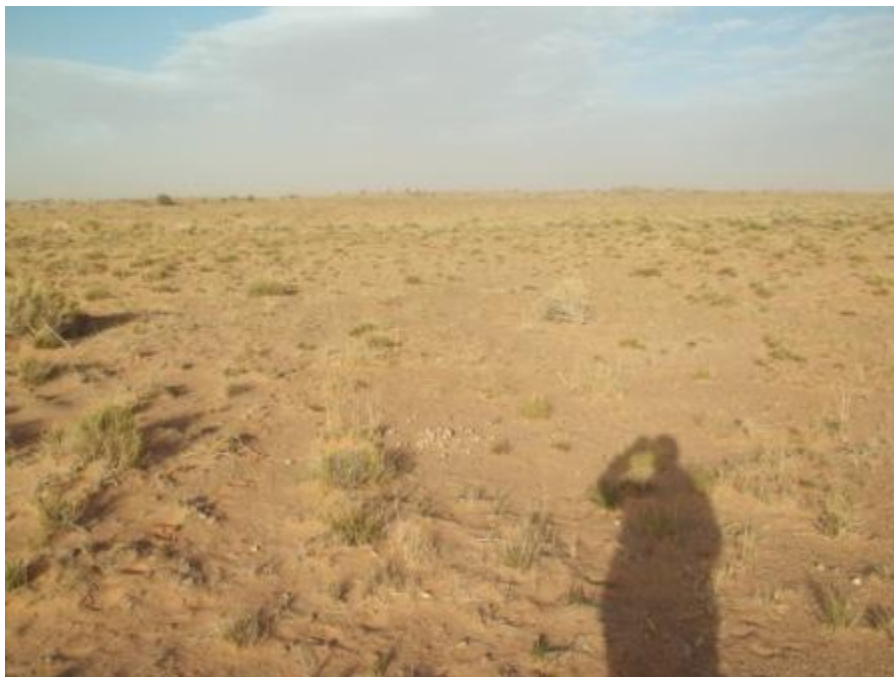
Photo 1

Mine Site #701

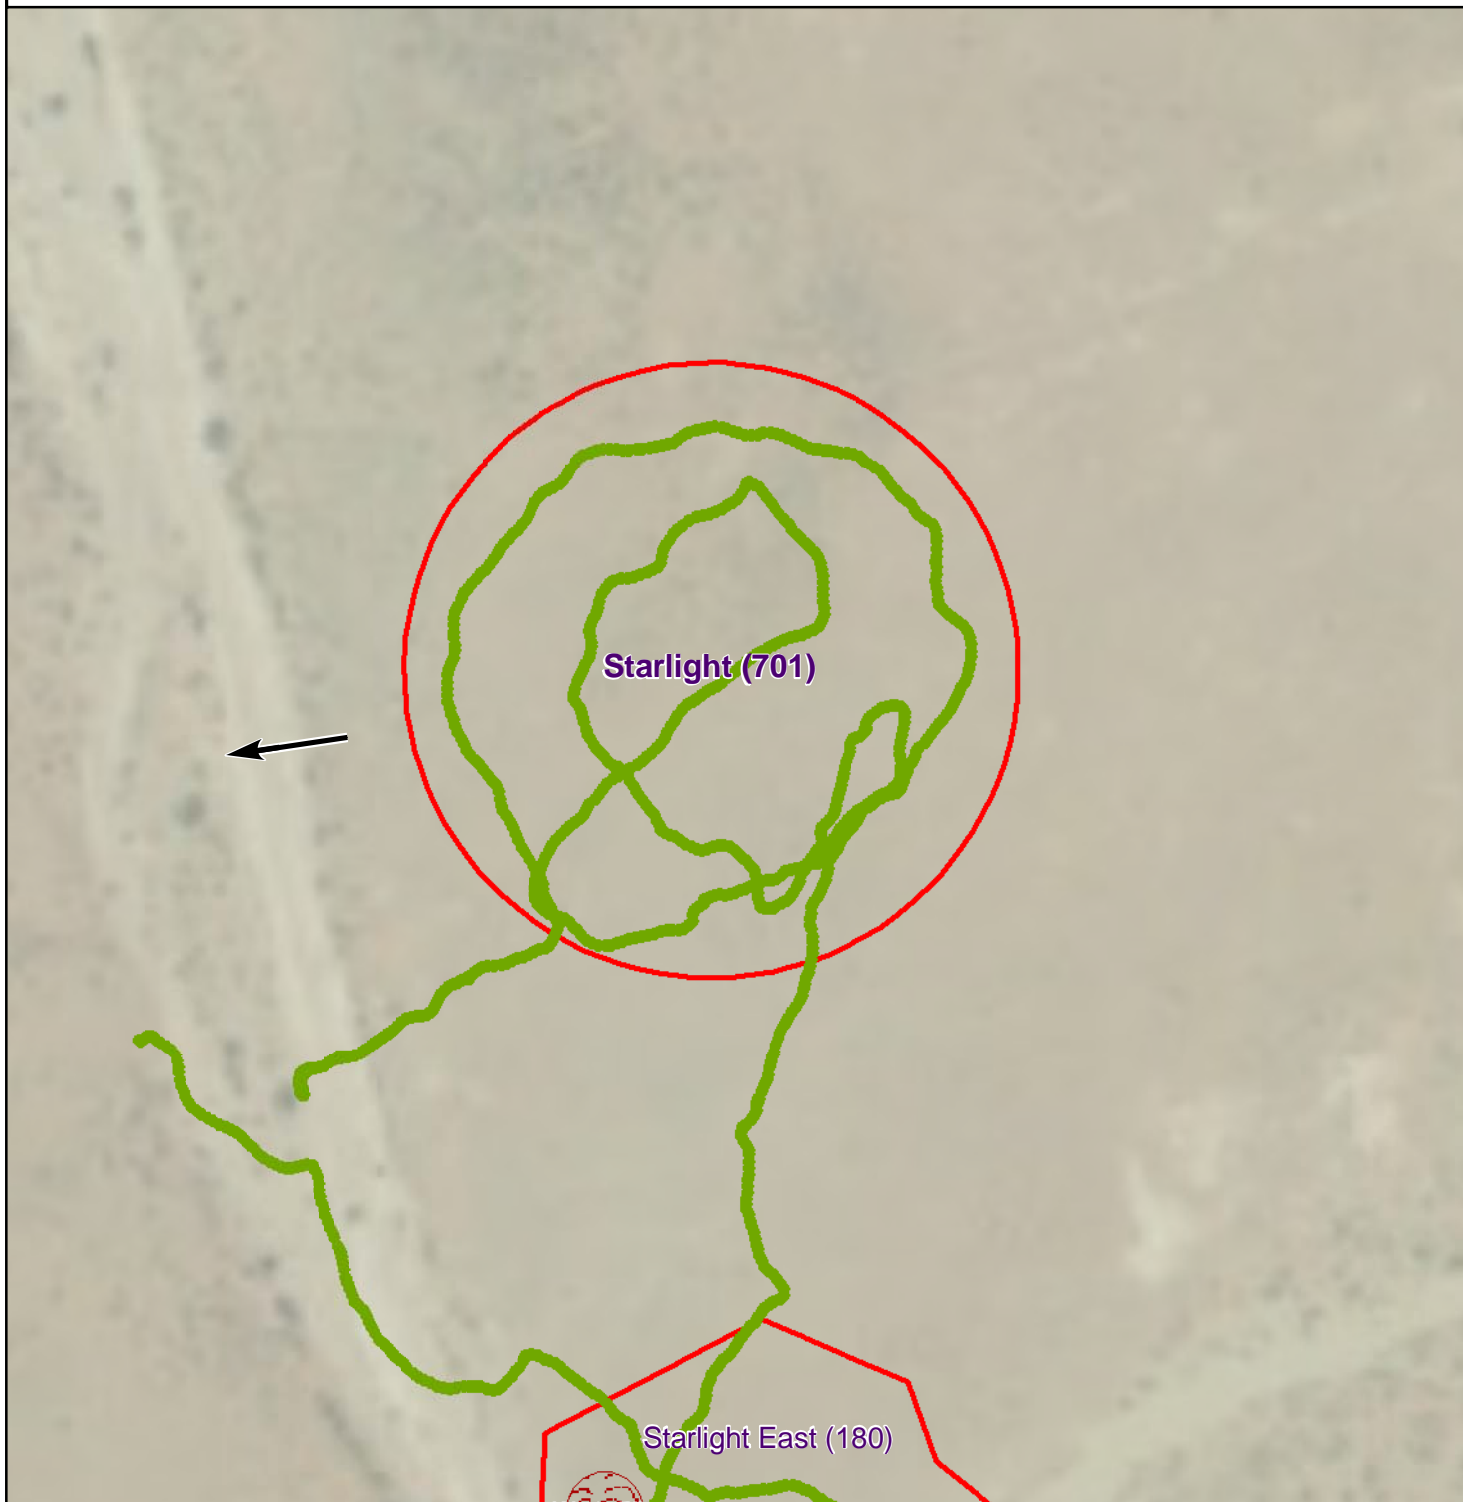
**Figure 1 - Gamma Radiation Measurements, Above Two Times Background
Starlight (701)
Oljato Chapter, Navajo Nation**

Gamma Radiation Measurements

Measured as counts per minute (cpm)

Average background 6,522 cpm
